Manhole Inspection Summary

Manhole # S04II2014MH

Insp Date: **7/14/06 9:37 AM**

Location Address: **3303 OLYMPIA AVE**

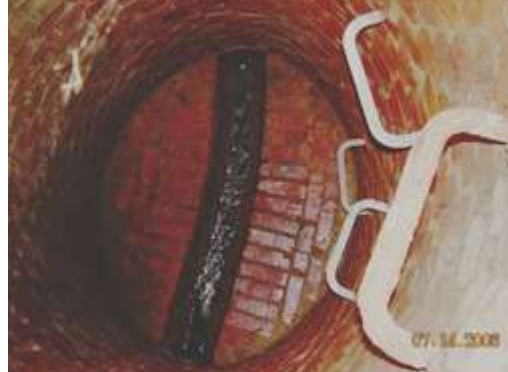
Top View

Corbel and Barrel infiltration. Bench debris. Corroded steps.

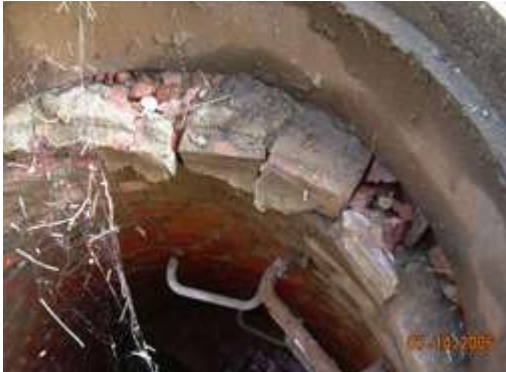
Defect

Frame leaks. Frame offset. Adjustment deterioration and loose brick. Adjustment and Corbel infiltration.

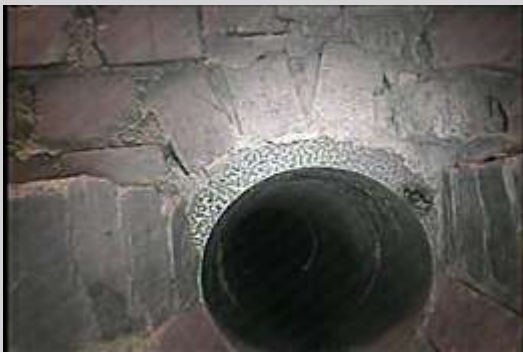
8 in. Circular Gravity Sewer Pipe Out @ 12 O'Clock

Comments **The I6 pipe seal is not flush to the pipe. The O12 pipe picture shows Barrel deterioration and infiltration.**

Infiltration: **Evidence** Pipe Seal Cond: **Cracked**

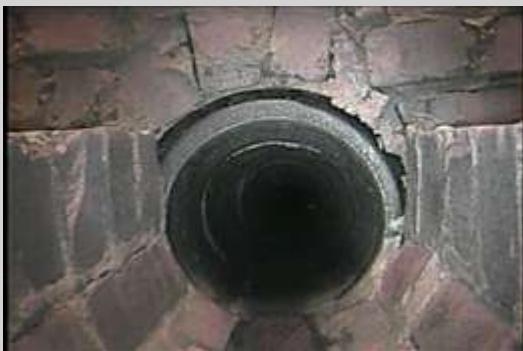
8 in. Circular Gravity Sewer Pipe In @ 7 O'Clock

Infiltration: **Evidence** Pipe Seal Cond: **Unknown**
